**Flood Control Project Maintenance
Levee Inspections**
LMA District Cover Sheet
Spring 2017 Levee Inspection Results

Reclamation District No. 0070 Meridian

Spring 2017 Levee Inspection Results

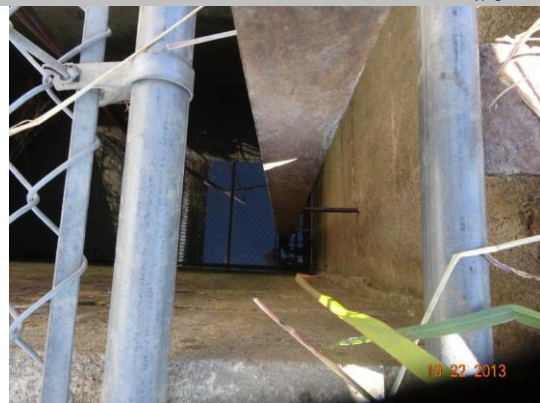
Photo 3 of 3 : UCIP_SP_2017_23962_42101.jpg

Photo of the concrete distribution box located on waterward side.

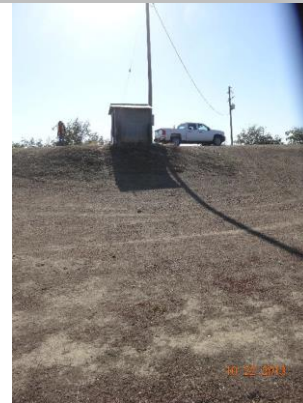
Photo 1 of 3 : UCIP_SP_2017_24166_42581.jpg

Comment Code					
Inspector Comment					
FS_ID:24166 DS_ID:21380 EP_NO: 9970 Repair Type: Non-Urgent Crossing Status: Found UCIP Comments: Need to coordinate with owner to determine status of crossing. No pump is located inside the pump house located on waterward side. If crossing is no longer in use owner will need to contact the CVFPB to comply with Title 23. Dense vegetation limits the inspector's visibility to identify signs of pipe failure (leaks) along the slope. Recommend removing vegetation along pipe alignment to conduct proper inspection of structure and appurtenances. This crossing is referenced in the USACE Periodic Inspection as item USACE_CESPK_MRD2_2012_p_0274. FIELD_STRUCT_DESC: 10-inch steel pipe through the levee, 4.8 feet below the crown. CM cutoff wall around pipe at center of levee. Siphon breaker on landward slope--not found. Pump in pump house on waterward shoulder. Shut-off valve on landward side. Concrete discharge box at landward toe. (USACE-1953). This entry matches the Drainage or Irrigation Structure referenced in O&M manual (Station 526+71). This pipe was retained under ABO No. 9970 (1974). FS Date: 10/22/2013

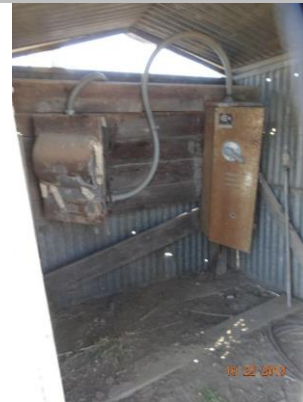
Photo 3 of 3 : UCIP_SP_2017_24166_42583.jpg

View of the inside of pump house--no pump.

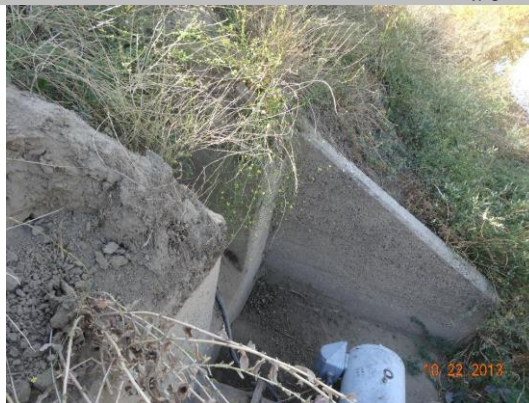
Photo 3 of 3 : UCIP_SP_2017_23964_42113.jpg

Comment Code						
Inspector Comment						
FS_ID:23964 DS_ID:21383 EP_NO: 9984 Repair Type: Non-Urgent Crossing Status: Found UCIP Comments: Will need to contact owner. Need to obtain maintenance records and clarify modifications made at to crossing (size). Additional crossing visible through concrete headwall on landward side--crossing has been capped (see photo). NEED TO CONFIRM PIPE SIZE!!!! This crossing is referenced in the USACE Periodic Inspection as item USACE_CESPK_MRD2_2012_p_0289. FIELD_STRUCT_DESC: 12-inch (not 24-inch as mentioned in desk study) steel pipe through the levee, 13.8 feet below the crown. Gate valve on the waterward side. Pump in pump house on the waterward side. Concrete distribution box at the landward toe. (USACE-1953). This entry matches the Drainage or Irrigation Structure referenced in O&M manual (Station 555+09). This pipe was retained under ABO No. 9984 (1974). FS Date: 10/22/2013

Crossing appears altered on waterward side.

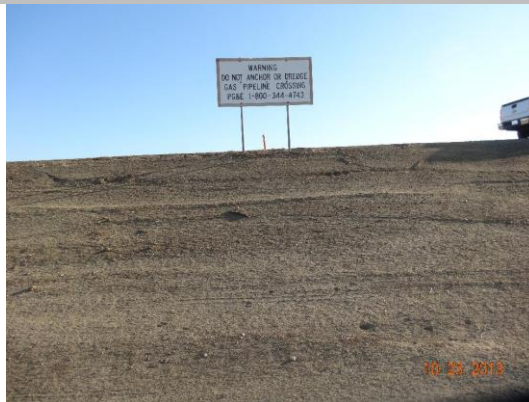
Photo 2 of 3 : UCIP_SP_2017_23965_42121.jpg

View of waterward slope.

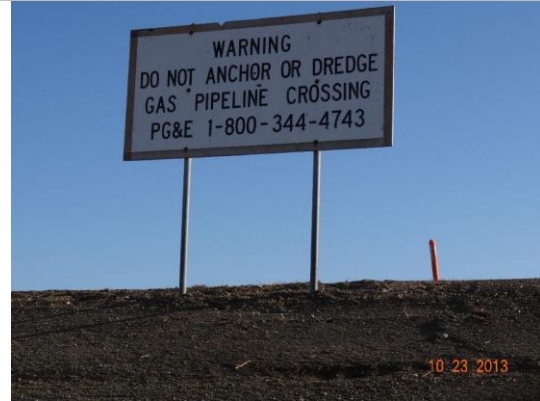
Photo 3 of 3 : UCIP_SP_2017_23965_42122.jpg

LM Start	6.28	Rating **	M	Issue No.	94 (cont)	
LM End	6.28	Issue Type +	En	Location *	LS	
Category	Supplemental			GPS Latitude/Longitude		
				Start	End	
Item	DWR UCIP Field Study			39.133847 °	39.133847 °	
				-121.937689 °	-121.937689 °	
DWR ID						
Comment Code						
Inspector Comment						
FS_ID:23965 DS_ID:21385 EP_NO: 4383 Repair Type: Non-Urgent Crossing Status: Found UCIP Comments: Need to contact owner to determine if crossing is still active and to determine last inspection date. Will need copy of letter showing crossings passed inspection. This crossing is referenced in the USACE Periodic Inspection as item USACE_CESPK_MRD2_2012_p_0319. FIELD_STRUCT_DESC: 8 5/8-inch steel gas pipe through the levee, 3.5 feet below the crown. Concrete cutoff wall around pipe at center of levee. Rock revetment on waterward slope. (Permit No. 4383-1963) FS Date: 10/23/2013

Sign visible on waterward side.

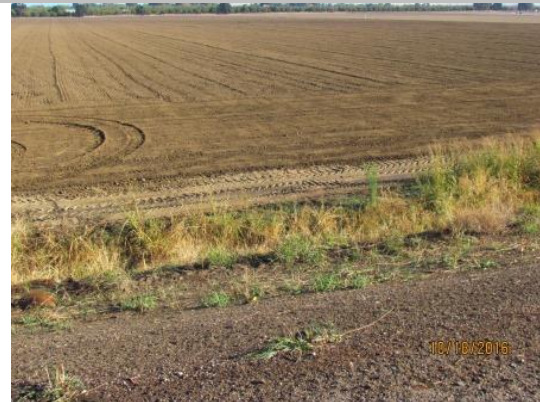
Photo 1 of 1 : SP_2017_RD0070_30_56_20170315_00009.jpg

LM Start	6.32	Rating **	M	Issue No.	56
LM End	7.09	Issue Type +	En	Location *	LS
Category	Earthen Levee			GPS Latitude/Longitude	
				Start	End
Item	Encroachments			39.133450 °	39.129024 °
				-121.937361 °	-121.924632 °
DWR ID	DWR_RD0070_02_f_2016_56				
Comment Code					
DT : Ditch					
Inspector Comment

View of a ditch at the landside toe.

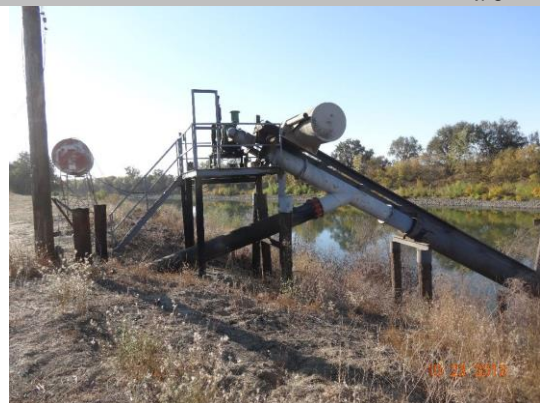
Photo 2 of 3 : UCIP_SP_2017_46424_42049.jpg

Pipe and pump set up on waterward side.

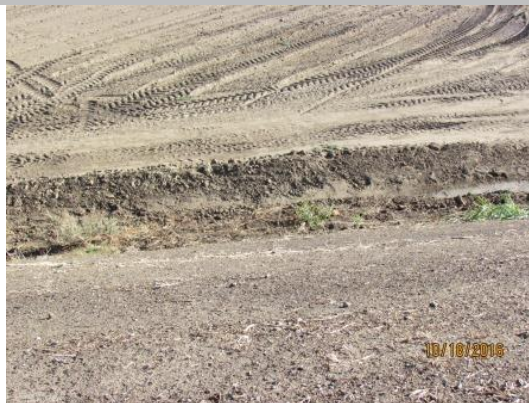
Photo 1 of 1 : SP_2017_RD0070_30_57_20170315_00010.jpg

LM Start	7.18	Rating **	M	Issue No.	57
LM End	7.18	Issue Type +	En	Location *	LS
Category	Earthen Levee			GPS Latitude/Longitude	
				Start	End
Item	Encroachments			39.128114 °	39.128114 °
				-121.923429 °	-121.923429 °
DWR ID	DWR_RD0070_02_f_2016_57				
Comment Code					
DT : Ditch					
Inspector Comment

View of a ditch along the landside toe.

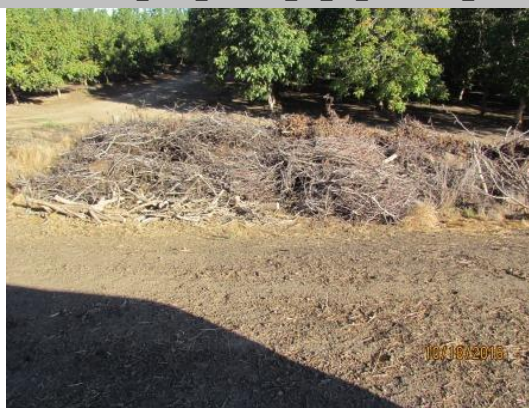
Photo 1 of 1 : SP_2017_RD0070_30_58_20170315_00011.jpg

LM Start	7.64	Rating **	U	Issue No.	58
LM End	7.64	Issue Type +	En	Location *	LS
Category	Earthen Levee			GPS Latitude/Longitude	
				Start	End
Item	Encroachments			39.124493 °	39.124493 °
				-121.917090 °	-121.917090 °
DWR ID	DWR_RD0070_02_f_2016_58				
Comment Code					
PR : Prunings					
Inspector Comment					
Remove prunings from the landside toe.

View of the prunings along the landside toe.

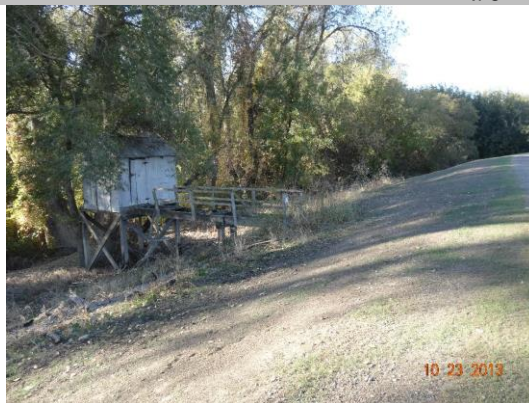
Photo 1 of 3 : UCIP_SP_2017_23966_42128.jpg

Comment Code					
Inspector Comment					
FS_ID:23966 DS_ID:21387 EP_NO: 9966 Repair Type: Non-Urgent Crossing Status: Indicator Found UCIP Comments: Pipe daylight at waterward side blocked. Unable to determine if connection is present--need to contact owner to determine if owner plans to use. If crossing is no longer in use owner will need to coordinate with DWR inspector and CVFPB to remove according to Title 23 requirements. Unable to determine if crossing is in use. This crossing is referenced in the USACE Periodic Inspection as item USACE_CESPK_MRD2_2012_p_0371. FIELD_STRUCT_DESC: 10-inch steel pipe and 1.5-inch electrical conduit thorough the levee, 12.0 and 8.0 feet below the crown, respectively. Pipe is concrete encased under the crown, between the shoulders. Two concrete cutoff walls under each shoulder. Pump and gate valve on pile structure in stream. Walkway to pump. Concrete standpipe on the landward side. (USACE-1953). This entry matches the Drainage or Irrigation Structure referenced in O&M manual (Station 689+50). Pipe and conduit were retained under ABO No. 11496 (1975). FS Date: 10/23/2013

Pump house located on waterward side.

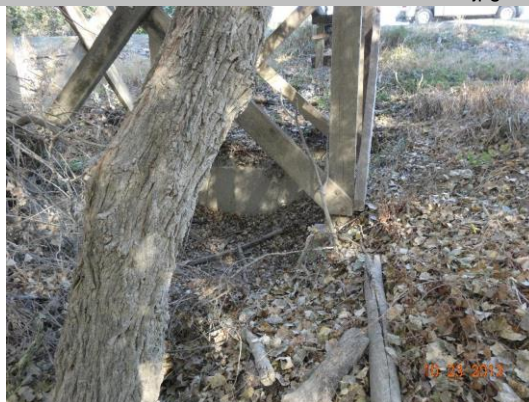
Photo 2 of 3 : UCIP_SP_2017_23966_42126.jpg

Concrete headwall located on waterward side.

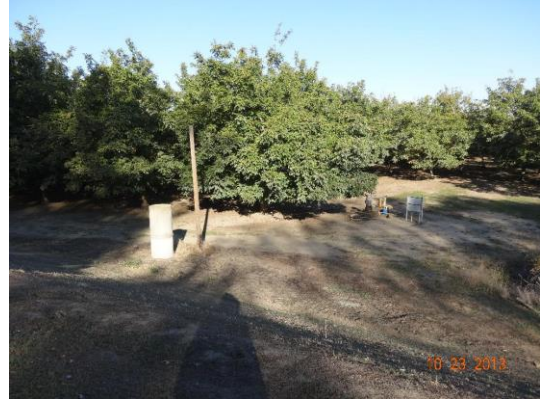
Photo 3 of 3 : UCIP_SP_2017_23966_42127.jpg

Comment Code					
Inspector Comment					
FS_ID:23966 DS_ID:21387 EP_NO: 9966 Repair Type: Non-Urgent Crossing Status: Indicator Found UCIP Comments: Pipe daylight at waterward side blocked. Unable to determine if connection is present--need to contact owner to determine if owner plans to use. If crossing is no longer in use owner will need to coordinate with DWR inspector and CVFPB to remove according to Title 23 requirements. Unable to determine if crossing is in use. This crossing is referenced in the USACE Periodic Inspection as item USACE_CESPK_MRD2_2012_p_0371. FIELD_STRUCT_DESC: 10-inch steel pipe and 1.5-inch electrical conduit thorough the levee, 12.0 and 8.0 feet below the crown, respectively. Pipe is concrete encased under the crown, between the shoulders. Two concrete cutoff walls under each shoulder. Pump and gate valve on pile structure in stream. Walkway to pump. Concrete standpipe on the landward side. (USACE-1953). This entry matches the Drainage or Irrigation Structure referenced in O&M manual (Station 689+50). Pipe and conduit were retained under ABO No. 11496 (1975). FS Date: 10/23/2013

Stand pipe located on landward side.

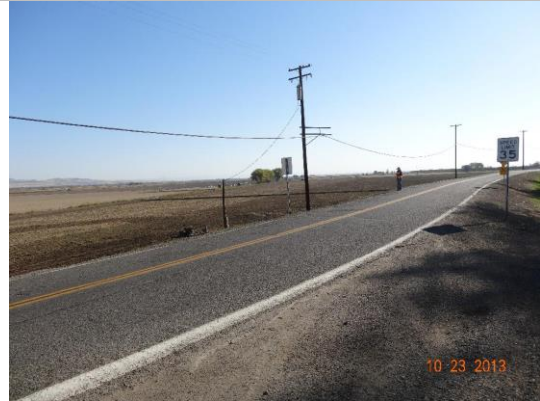
Photo 1 of 3 : UCIP_SP_2017_24191_42677.jpg

LM Start	7.92	Rating **	M	Issue No.	97
LM End	7.92	Issue Type +	En	Location *	LS
Category	Supplemental			GPS Latitude/Longitude	
				Start	End
Item	DWR UCIP Field Study			39.124543 °	39.124543 °
				-121.911996 °	-121.911996 °
DWR ID					
Comment Code					
Inspector Comment					
FS_ID:24191 DS_ID:21389 EP_NO: 1264 Repair Type: Non-Urgent Crossing Status: Indicator Found UCIP Comments: Need to coordinate with owner to determine status of crossing. If crossing is no longer in use owner will need to contact the CVFPB to comply with Title 23. This crossing is referenced in the USACE Periodic Inspection as item USACE_CESPK_MRD2_2012_p_0124. FIELD_STRUCT_DESC: Abandoned 10-inch (not 14-inch as specified in desk study) pipe through the levee, 5.0 feet below the crown. Pump on the waterward side. Double concrete discharge box at landward toe. (Permit No. 1264-1948) FS Date: 10/23/2013

View of levee crown at crossing.

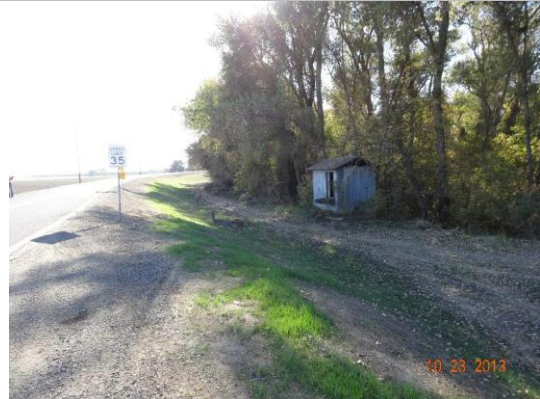
Photo 2 of 3 : UCIP_SP_2017_24191_42678.jpg

View of waterward side--only pump house of nearby crossing located downstream from crossing.

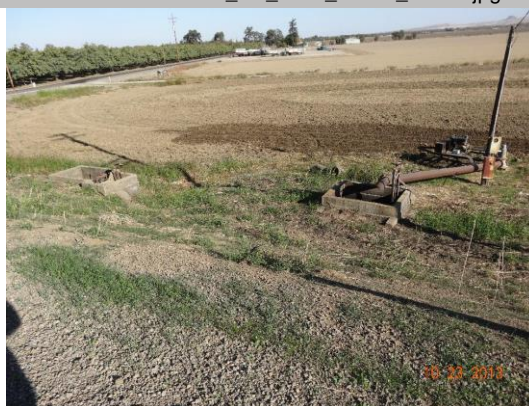
Photo 3 of 3 : UCIP_SP_2017_24191_42676.jpg

Comment Code						
Inspector Comment						
FS_ID:24191 DS_ID:21389 EP_NO: 1264 Repair Type: Non-Urgent Crossing Status: Indicator Found UCIP Comments: Need to coordinate with owner to determine status of crossing. If crossing is no longer in use owner will need to contact the CVFPB to comply with Title 23. This crossing is referenced in the USACE Periodic Inspection as item USACE_CESPK_MRD2_2012_p_0124. FIELD_STRUCT_DESC: Abandoned 10-inch (not 14-inch as specified in desk study) pipe through the levee, 5.0 feet below the crown. Pump on the waterward side. Double concrete discharge box at landward toe. (Permit No. 1264-1948) FS Date: 10/23/2013

View of landward side--two crossing nearby.

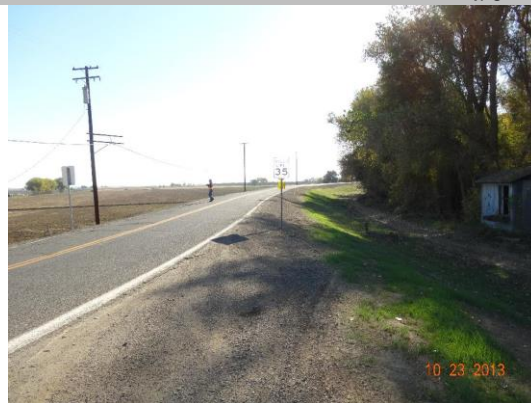
Photo 1 of 3 : UCIP_SP_2017_24190_42667.jpg

LM Start	7.92	Rating **	M	Issue No.	98 (cont)
LM End	7.92	Issue Type +	En	Location *	LS

View of levee crown at crossing.

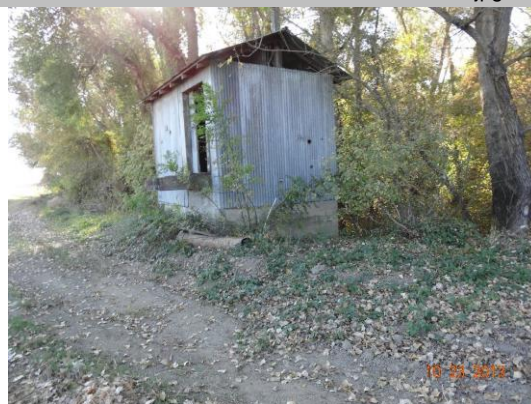
Photo 2 of 3 : UCIP_SP_2017_24190_42668.jpg

Pump house located on waterward side.

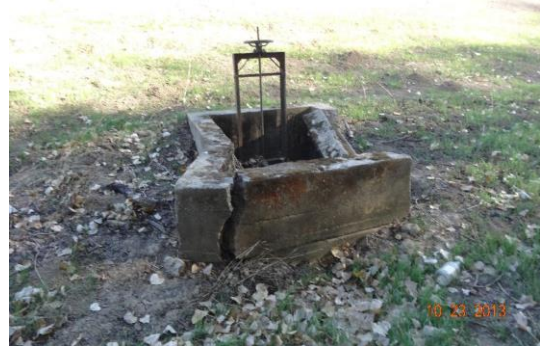
Photo 3 of 3 : UCIP_SP_2017_24190_42669.jpg

Item	DWR UCIP Field Study		39.124460 °	39.124460 °								
			-121.911932 °	-121.911932 °								
DWR ID												
Comment Code												
Inspector Comment												
FS_ID:24190 DS_ID:21388 EP_NO: 10008 Repair Type: Non-Urgent Crossing Status: Found UCIP Comments: Concrete distribution box is damage on waterward side. Need to contact owner to determine status of crossing. If crossing is no longer in use owner will need to coordinate with DWR inspector and CVFPB to remove according to Title 23 requirements. This crossing is referenced in the USACE Periodic Inspection as item USACE_CESPK_MRD2_2012_p_0380. FIELD_STRUCT_DESC: *ABANDONED* 18-inch steel pipe through the levee, 15.0 feet below the crown. Pump in pump house and slide gate on the waterward side. (USACE-1953). This entry matches the Drainage or Irrigation Structure referenced in O&M manual (Station 694+85). Concrete distribution box on landward side. This pipe was retained under ABO No. 10008 (1974). During field verification additional appurtenances were observed. An additional pipe on landward side drains into concrete distribution box. The concrete box connects to a second set of distribution boxes through a 24-inch concrete pipe approximately 36 feet upstream of crossing. Those boxes have a 10-inch pipe that appears to go through levee. FS Date: 10/23/2013

Damage concrete distribution box located on waterward side.

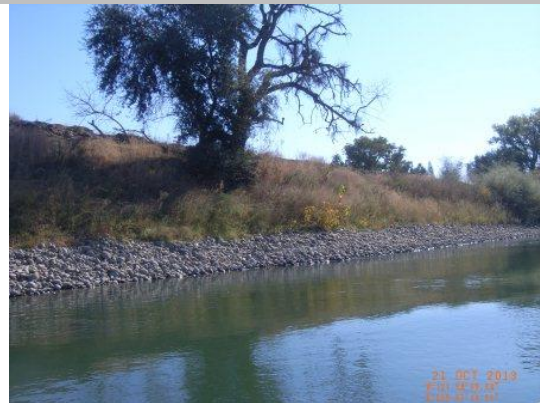
Photo 1 of 1 : SP_2017_RD0070_30_2_20170315_00002.jpg

LM Start	8.10	Rating **	M	Issue No.	2							
LM End	8.23	Issue Type +	Ma	Location *	WS							
Category	Supplemental		GPS Latitude/Longitude									
			Start	End								
Item	2015 USACE Erosion Survey, DRAFT		39.122459 °	39.120684 °								
			-121.910121 °	-121.909152 °								
DWR ID	DWR_RD0070_02_s_2016_2											
Comment Code												
Inspector Comment												
1997 - Critical Site - Erosion of cobble site on outside of a bend. Failure caused by erosion of a material from behind the cobbles and cobbles rolling down the slope. Failure is just above the toe levee. Some repairs had been done at the upstream end. 2004 - Some minor new erosion at the top of the berm. 2005 - Trees look okay and the downstream end has some new rock repair. Site is no longer critical. 2006 - No longer critical, some repairs. 2015: No observed changes. [2015 Site ID: SAC_130-0_L]

USACE 2013 Photo #1

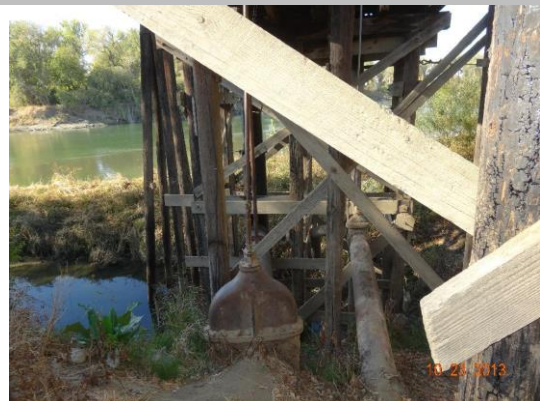
Photo 2 of 3 : UCIP_SP_2017_24108_42465.jpg

View of 16-inch pipe and 24-inch pipe with screw gate located on waterward side.

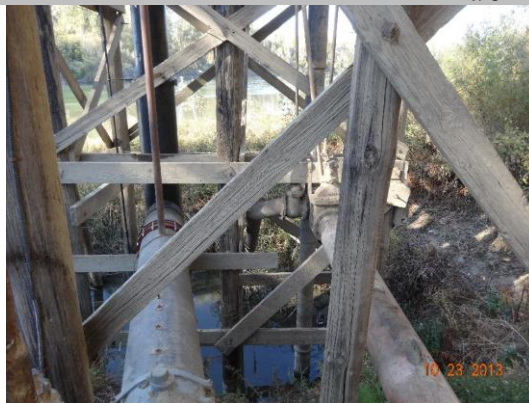
Photo 3 of 3 : UCIP_SP_2017_24108_42464.jpg

Item	DWR UCIP Field Study			39.110878 °		39.110878 °
				-121.902775 °		-121.902775 °
DWR ID						
Comment Code						
Inspector Comment						
FS_ID:24108 DS_ID:21423 EP_NO: 9971 Repair Type: Non-Urgent Crossing Status: Found UCIP Comments: Will need to contact owner. Need to obtain maintenance records and clarify modifications made to crossing (size). This crossing is referenced in the USACE Periodic Inspection as item USACE_CESPK_MRD2_2012_p_0433. FIELD_STRUCT_DESC: [Meridian Farms Water Com. Pumping Plant No. 3] 2 of 3: 16-inch pipe (not a 30-inch pipe as mentioned in desk study) through the levee, 20.5 feet below the crown. Gate valve on the waterward end. Pump on pile structure in stream. Wooden walkway to pump. Concrete distribution box on landward side. This pipe was retained under ABO No. 9971 (1974). Pumping plant is to be demolished under Permit No. 18762 (2013). FS Date: 10/23/2013

View of 16-inch pipe and 24-inch pipe located on waterward side.

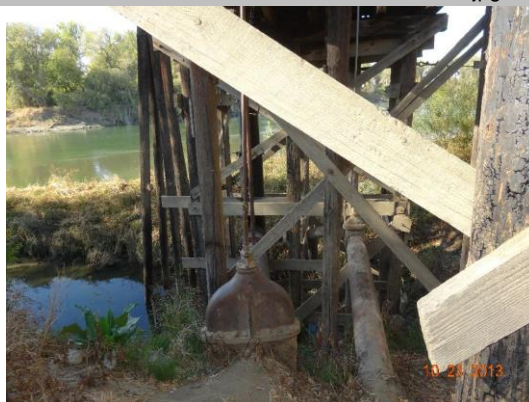
Photo 2 of 3 : UCIP_SP_2017_24107_42458.jpg

View of 16-inch pipe and 24-inch pipe through levee on waterward side.

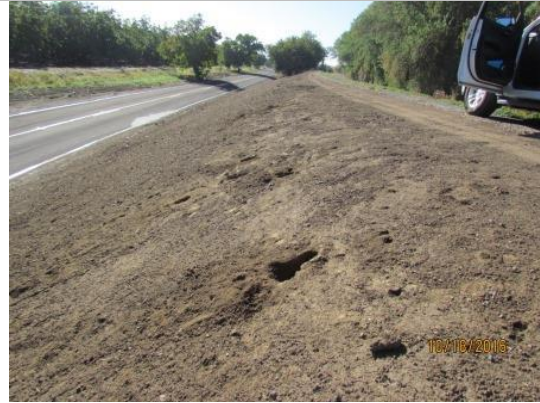
Photo 1 of 1 : SP_2017_RD0070_30_61_20170315_00012.jpg

LM Start	9.28	Rating **	M	Issue No.	61
LM End	9.28	Issue Type +	Ma	Location *	LS
Category	Earthen Levee			GPS Latitude/Longitude	
				Start	End
Item	Animal Control			39.107285 °	39.107285 °
				-121.900753 °	-121.900753 °
DWR ID	DWR_RD0070_02_f _ 2016_61				
Comment Code					
A3 : No rodents visible, but rodent burrows visible; need to backfill and compact or grout burrows.					
Inspector Comment

View of the rodent holes along the landside slope.

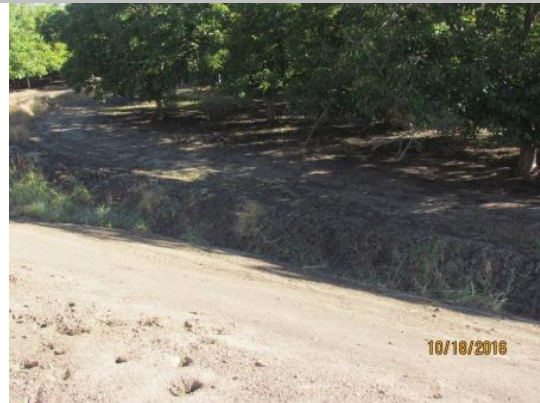
Photo 1 of 1 : SP_2017_RD0070_30_62_20170315_00013.jpg

LM Start	9.57	Rating **	U	Issue No.	62
LM End	9.70	Issue Type +	En	Location *	LS
Category	Earthen Levee			GPS Latitude/Longitude	
				Start	End
Item	Encroachments			39.103192 °	39.101213 °
				-121.899606 °	-121.899380 °
DWR ID	DWR_RD0070_02_f_2016_62				
Comment Code					
DT : Ditch					
Inspector Comment

View of a ditch along the landside toe.

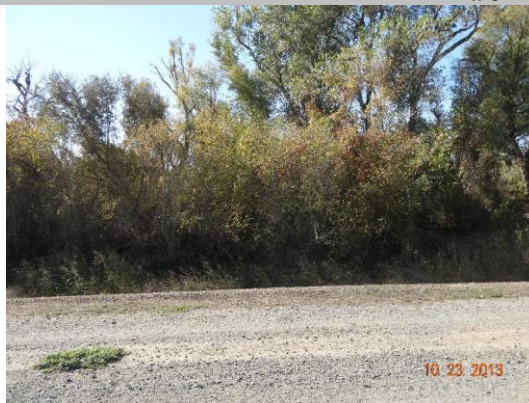
Photo 1 of 3 : UCIP_SP_2017_23967_42129.jpg

FS_ID:23967
 DS_ID:21396
 EP_NO: N/A
 Repair Type: Non-Urgent
 Crossing Status: Indicator Found
 UCIP Comments: No evidence of pipe is visible on waterward side. Need to coordinate with owner to determine status of crossing. If crossing is no longer in use owner will need to contact the CVFPB to comply with Title 23. This crossing is referenced in the USACE Periodic Inspection as item USACE_CESPK_MRD2_2012_p_0477.
 FIELD_STRUCT_DESC: *ABANDONED* 12-inch pipe through the levee, 3.1 feet below the crown. Siphon breaker in CM pipe riser on landward shoulder. Concrete plug at landward end. Wood distribution box on landward side at discharge end. (USACE-1953). This entry matches the Drainage or Irrigation Structure referenced in O&M manual (Station 813+00). (Cat. IV-A)
 FS Date: 10/23/2013

View of waterward side.

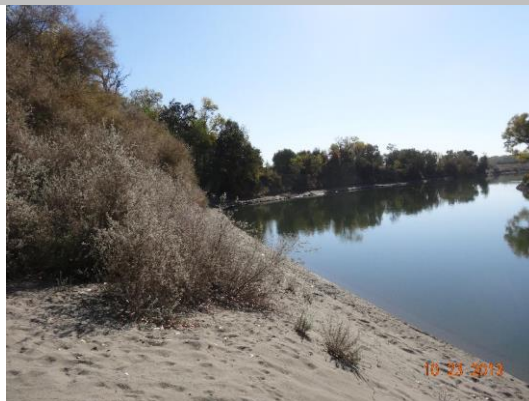
Photo 2 of 3 : UCIP_SP_2017_23967_42132.jpg

No pipe exists levee on waterward side only CMP riser present on landward side.

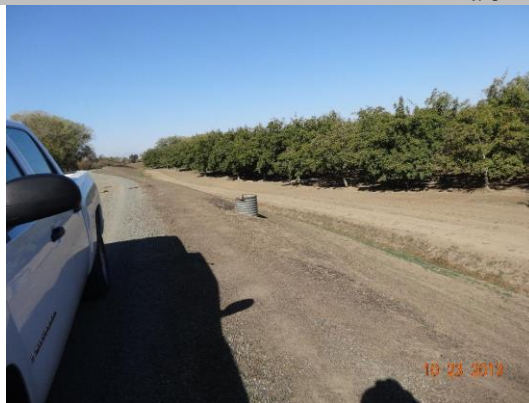
Photo 3 of 3 : UCIP_SP_2017_23967_42131.jpg

Comment Code					
Inspector Comment					
FS_ID:23967					
DS_ID:21396					
EP_NO: N/A					
Repair Type: Non-Urgent					
Crossing Status: Indicator Found					
UCIP Comments: No evidence of pipe is visible on waterward side.					
Need to coordinate with owner to determine status of crossing. If					
crossing is no longer in use owner will need to contact the CVFPB to					
comply with Title 23. This crossing is referenced in the USACE Periodic					
Inspection as item USACE_CESPK_MRD2_2012_p_0477.					
FIELD_STRUCT_DESC: *ABANDONED* 12-inch pipe through the					
levee, 3.1 feet below the crown. Siphon breaker in CM pipe riser on					
landward shoulder. Concrete plug at landward end. Wood distribution					
box on landward side at discharge end. (USACE-1953). This entry					
matches the Drainage or Irrigation Structure referenced in O&M manual					
(Station 813+00). (Cat. IV-A)					
FS Date: 10/23/2013

CMP riser located on landward shoulder.

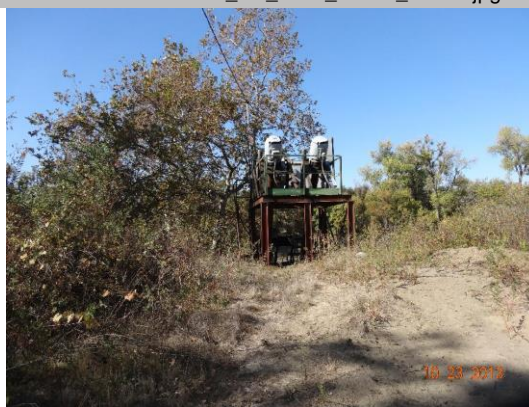
Photo 2 of 3 : UCIP_SP_2017_24195_42685.jpg

Pump station located on waterward side.

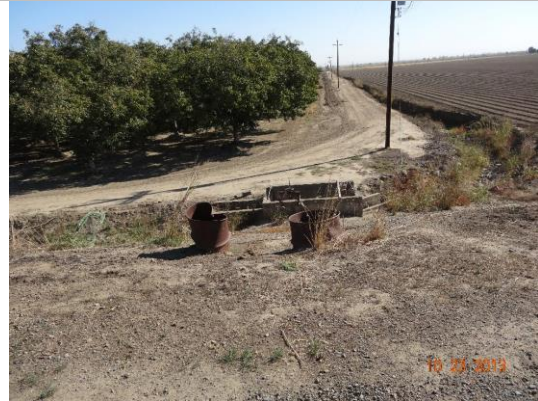
Photo 3 of 3 : UCIP_SP_2017_24195_42688.jpg

FS_ID:24195
DS_ID:21398
EP_NO: 1162
Repair Type: Non-Urgent
Crossing Status: Found
UCIP Comments: Need to verify status of crossing--variation in pipe size. 18 inch pipe listed in desk study and 20 inch pipe found in field. Damage to siphon breaker housing unit. This crossing is referenced in the USACE Periodic Inspection as item USACE_CESPK_MRD2_2012_p_0482.
FIELD_STRUCT_DESC: 1 of 2: 20-inch (not 18-inch as listed in desk study) steel pipe through the levee, 3.7 feet below the crown. Two concrete cutoff walls around pipe, at levee shoulders. Siphon breakers in steel pipe risers on landward shoulder. Slant pumps on wooden pump structure on waterward side. Two CM pipe risers under pump structure at waterward toe. Distribution box at landward toe. (Permit No. 1162-1946) This entry matches the Drainage or Irrigation Structure referenced in O&M manual (Station 824+00).
FS Date: 10/23/2013

View of landward side.

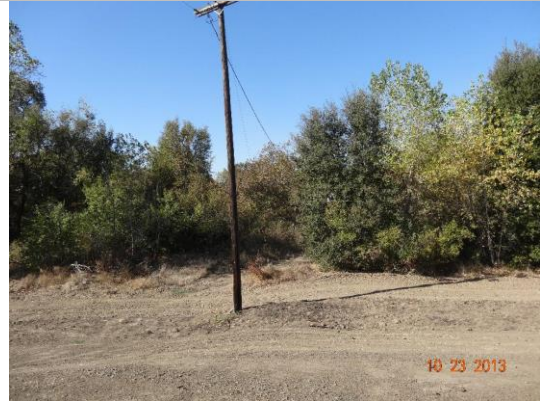
Photo 1 of 3 : UCIP_SP_2017_24196_42693.jpg

FS_ID:24196
DS_ID:21430
EP_NO: 1162
Repair Type: Non-Urgent
Crossing Status: Found
UCIP Comments: Need to verify status of crossing--variation in pipe size. 18 inch pipe listed in desk study and 20 inch pipe found in field. This crossing is referenced in the USACE Periodic Inspection as item USACE_CESPK_MRD2_2012_p_0482.
FIELD_STRUCT_DESC: 2 of 2: 20-inch (not 18-inch as listed in desk study) steel pipe through the levee, 3.7 feet below the crown. Two concrete cutoff walls around pipe, at levee shoulders. Siphon breakers in steel pipe risers on landward shoulder. Slant pumps on wooden pump structure on waterward side. Two CM pipe risers under pump structure at waterward toe. Distribution box at landward toe. (Permit No. 1162-1946) This entry matches the Drainage or Irrigation Structure referenced in O&M manual (Station 824+00).
FS Date: 10/23/2013

View of waterward side path to pump station is behind the power pole.

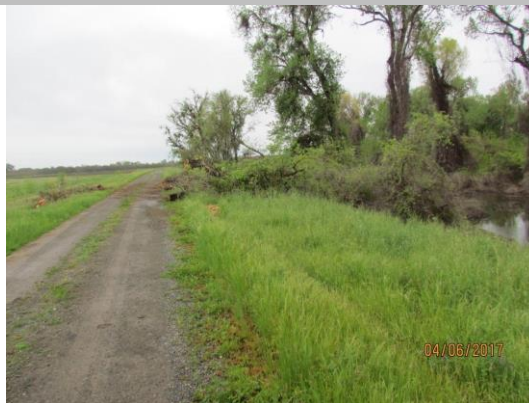
Photo 1 of 1 : SP_2017_RD0070_30_70_20170410_00123.jpg

View of the tree along the waterside slope and toe.

LM Start	11.26	Rating **	M	Issue No.	70
LM End	11.26	Issue Type +	En	Location *	WS
Category	Earthen Levee			GPS Latitude/Longitude	
				Start	End
Item	Encroachments			39.083648 °	39.083648 °
				-121.888233 °	-121.888233 °
DWR ID	DWR_RD0070_02_s_2017_70				
Comment Code					
TR : Tree or limb					
Inspector Comment					
Remove the tree from the waterside slope and toe.

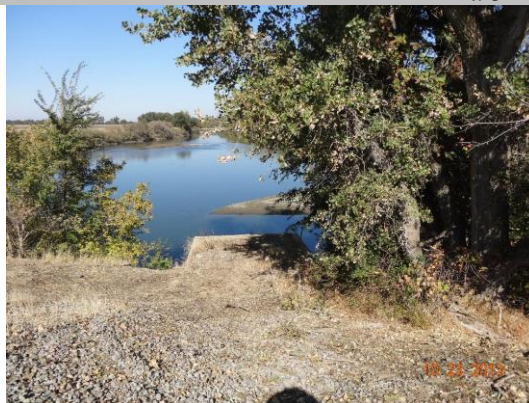
Photo 1 of 3 : UCIP_SP_2017_24197_42699.jpg

FS_ID:24197
DS_ID:21400
EP_NO: 9986
Repair Type: Non-Urgent
Crossing Status: Indicator Found
UCIP Comments: Need to coordinate with owner to determine status of crossing. If crossing is no longer in use owner will need to contact the CVFPB to comply with Title 23. This crossing is referenced in the USACE Periodic Inspection as item USACE_CESPK_MRD2_2012_p_0527.
FIELD_STRUCT_DESC: 30-inch steel pipe through the levee, 27.5 feet below the crown. Two electric gate valves in concrete pit on waterward end at end of discharge pipe. Two slant pumps on waterward slope. Control switches in CM shed at waterward shoulder. (USACE-1953). This entry matches the Drainage or Irrigation Structure referenced in O&M manual (Station 889+72). This pipe was retained under ABO No. 9986 (1974). One pump and one gate valve installed under Permit No. 5193 (1966). This pumping plant was demolished with pipes grouted and abandoned under Permit No. 18323 (2009).

View of waterward side.

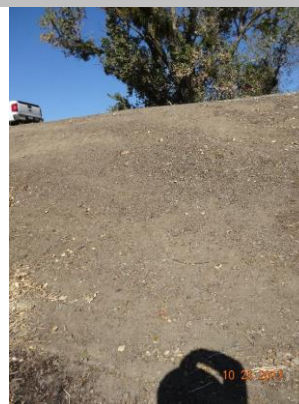
Photo 2 of 3 : UCIP_SP_2017_24197_42698.jpg

View of landward slope.

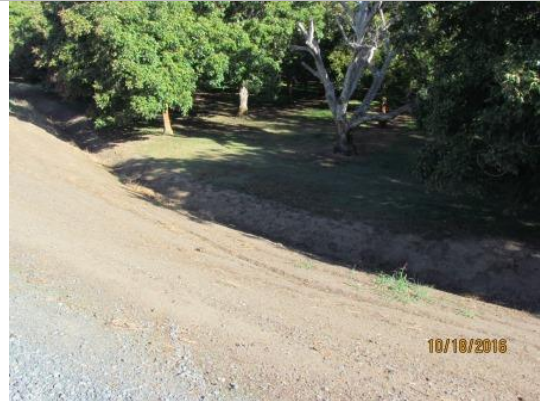
Photo 1 of 1 : SP_2017_RD0070_30_65_20170315_00014.jpg

LM Start	12.26	Rating **	M	Issue No.	65
LM End	12.26	Issue Type +	En	Location *	LS
Category	Earthen Levee			GPS Latitude/Longitude	
				Start	End
Item	Encroachments			39.073416 °	39.073416 °
				-121.889254 °	-121.889254 °
DWR ID	DWR_RD0070_02_f_2016_65				
Comment Code					
DT : Ditch					
Inspector Comment

View of a ditch along the landside toe.

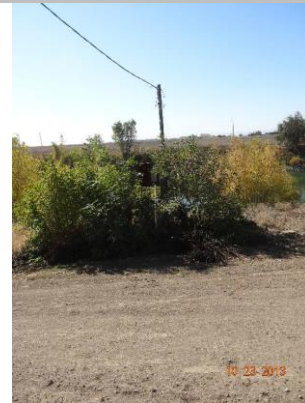
Photo 1 of 3 : UCIP_SP_2017_47033_42141.jpg

Comment Code					
Inspector Comment					
FS_ID:47033 DS_ID:21402 EP_NO: 9997 Repair Type: Non-Urgent Crossing Status: Found UCIP Comments: Debris found on waterward side along berm running parallel to levee. Two crossing found--Need to coordinate with owner to determine permit for second crossing and status of crossing. If crossing is no longer in use owner will need to contact the CVFPB to comply with Title 23. Dense vegetation limits the inspector's visibility to identify signs of pipe failure (leaks) along the waterward slope. Recommend removing vegetation along pipe alignment to conduct proper inspection of structure and appurtenances. This crossing is referenced in the USACE Periodic Inspection as item USACE_CESPK_MRD2_2012_p_0559. FIELD_STRUCT_DESC: 12-inch steel pipe through the levee, 3.5 feet below the crown. Siphon breaker in CM pipe riser on landward shoulder. Control valve and pump on waterward side. Power pole on waterward shoulder. Discharge box at landward toe. (USACE-1953). This entry matches the Drainage or Irrigation Structure referenced in O&M manual (Station 930+22). This pipe was retained under ABO No. 9997 (1974). FS Date: 10/23/2013

Crossing appurtenances located near brush and power pole on waterward side.

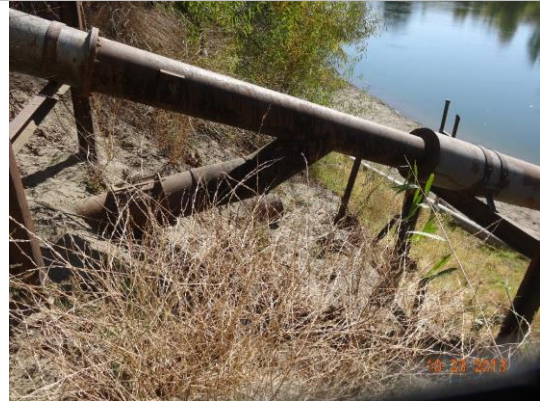
Photo 2 of 3 : UCIP_SP_2017_47033_42139.jpg

FS_ID:47033
DS_ID:21402
EP_NO: 9997
Repair Type: Non-Urgent
Crossing Status: Found
UCIP Comments: Debris found on waterward side along berm running parallel to levee. Two crossing found--Need to coordinate with owner to determine permit for second crossing and status of crossing. If crossing is no longer in use owner will need to contact the CVFPB to comply with Title 23. Dense vegetation limits the inspector's visibility to identify signs of pipe failure (leaks) along the waterward slope. Recommend removing vegetation along pipe alignment to conduct proper inspection of structure and appurtenances. This crossing is referenced in the USACE Periodic Inspection as item USACE_CESPK_MRD2_2012_p_0559.
FIELD_STRUCT_DESC: 12-inch steel pipe through the levee, 3.5 feet below the crown. Siphon breaker in CM pipe riser on landward shoulder. Control valve and pump on waterward side. Power pole on waterward shoulder. Discharge box at landward toe. (USACE-1953). This entry matches the Drainage or Irrigation Structure referenced in O&M manual (Station 930+22). This pipe was retained under ABO No. 9997 (1974).

Pipe crossing on waterward side. Second pipe comes out approximately 3 feet downstream from this crossing.

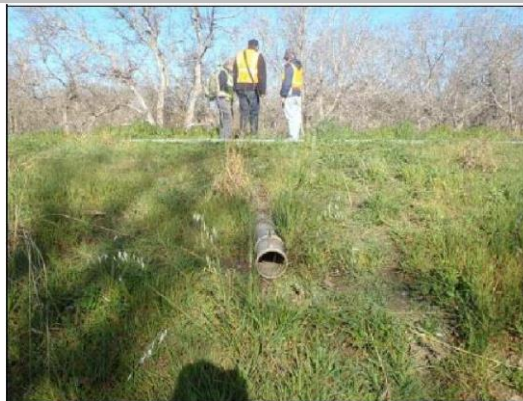
Photo 3 of 3 : UCIP_SP_2017_50086_42881.jpg

Item	DWR UCIP Field Study			39.072480 °	39.072480 °	
				-121.886540 °	-121.886540 °	
DWR ID						
Comment Code						
Inspector Comment						
FS_ID:50086 DS_ID:24744 EP_NO: N/A Repair Type: Non-Urgent Crossing Status: Found UCIP Comments: 07/07/2016 Dense vegetation on both slopes. No damage was observed on levee slopes or crown, crossing was downgraded from Urgent to Non-Urgent. No permit found for crossing. Need to recheck during winter. According to Andy Duffey, District Representative, CVFPB has issued a enforcement letter to owner dated 6/23/2016. (DWR UCIP - omagana)10/23/2013 No records were found during initial desk study--need to contact owner to obtain permit number authorizing work. Owner will need to coordinate with DWR Inspector and CVFPB to remove crossing according to Title 23 requirements. (DWR UCIP - omagana) FIELD_STRUCT_DESC: 6-inch aluminum irrigation pipe sleeved through a 10-inch corrugated metal pipe (annular space not grouted) through the levee, 1.5 feet below the crown. Pipe extends down both slopes about 2 feet below crown. FS Date: 7/7/2016 10:39:00 AM

View of pipe through levee--photo is from USACE PI Draft Report dated 6-2012.

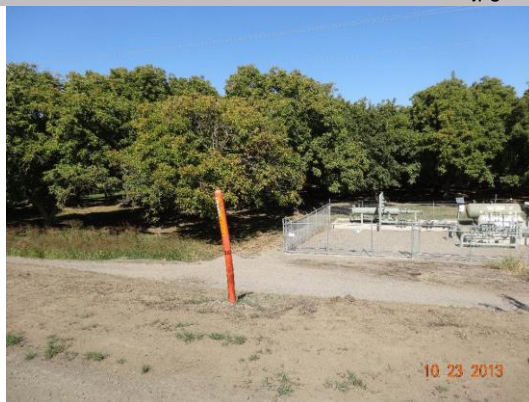
Photo 2 of 3 : UCIP_SP_2017_23984_42171.jpg

Marker on landward side.

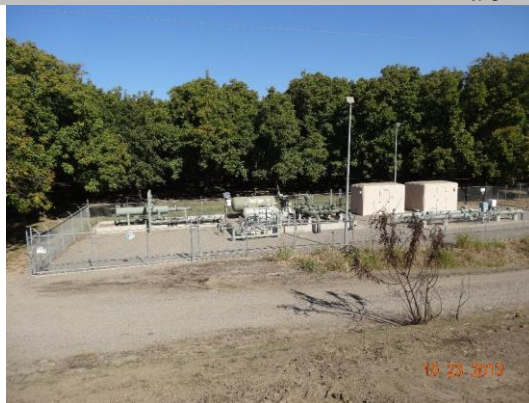
Photo 3 of 3 : UCIP_SP_2017_23984_42170.jpg

Item	DWR UCIP Field Study			39.072512 °		39.072512 °
				-121.886000 °		-121.886000 °
DWR ID						
Comment Code						
Inspector Comment						
FS_ID:23984 DS_ID:21403 EP_NO: 3800 Repair Type: Non-Urgent Crossing Status: Indicator Found UCIP Comments: Need to contact owner to determine if crossing is still active and to determine last inspection date. Will need copy of letter showing crossings passed inspection. This crossing is referenced in the USACE Periodic Inspection as item USACE_CESPK_MRD2_2012_p_0568. FIELD_STRUCT_DESC: 20-inch steel gas pipe through the levee, 3.0 feet below the crown. Concrete cutoff wall around pipe at center of levee. Marker sign on waterward shoulder. Natural gas equipment pad at landward toe. (Permit No. 3800-1962) FS Date: 10/23/2013

Additional appurtenances located on landward side.

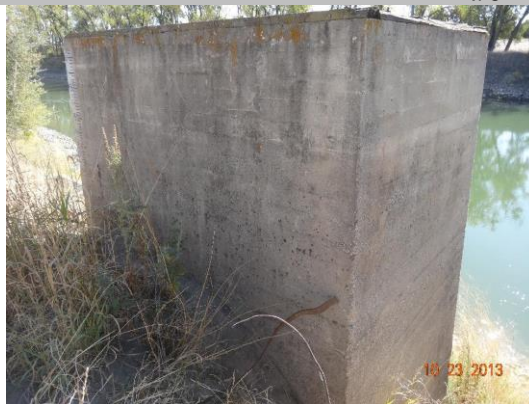
Photo 1 of 1 : UCIP_SP_2017_47039_42800.jpg

Comment Code					
Inspector Comment					
FS_ID:47039 DS_ID:21407 EP_NO: 9995 Repair Type: Non-Urgent Crossing Status: Indicator Found UCIP Comments: Records show a 24-inch iron pipe through the waterward side along the old gaging station with the concrete struture located on the waterward slope. FIELD_STRUCT_DESC: [RD No. 70 Drainage Pump] 1 of 5: 30-inch steel drainpipe through the levee at low elevation. Pipe is concrete encased under the crown, between the shoulders. Slide gate on landward side. Flap gate in secured structure on the waterward end. This pipe was retained under ABO No. 9995 (1974). Concrete structure (10x12 foot) on waterward end at discharge end of pipe installed under Permit No. 13420 (1982). FS Date: 10/23/2013

Remains of old gaging station associated with 24-inch iron pipe that extends into the river.

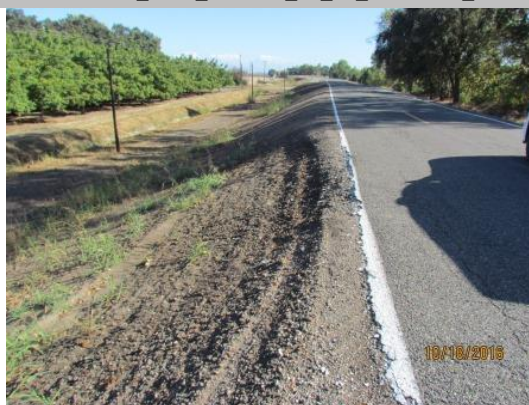
Photo 1 of 1 : SP_2017_RD0070_30_66_20170315_00015.jpg

LM Start	14.14	Rating **	M	Issue No.	66
LM End	14.14	Issue Type +	Ma	Location *	LS
Category	Earthen Levee			GPS Latitude/Longitude	
				Start	End
Item	Slope Stability			39.069849 °	39.069849 °
				-121.857267 °	-121.857267 °
DWR ID	DWR_RD0070_02_f_2016_66				
Comment Code					
S1 : Repair slope instability.					
Inspector Comment

View of slope instability along the landside slope.

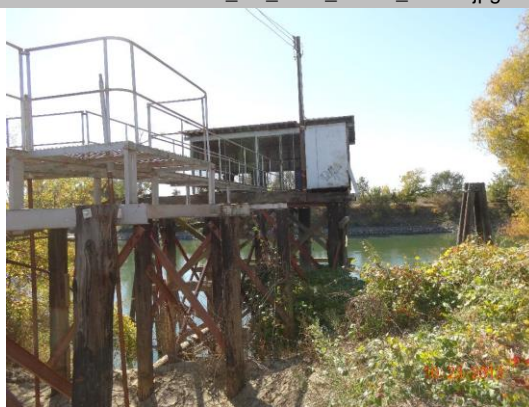
Photo 2 of 3 : UCIP_SP_2017_24229_42849.jpg

Pump house located on waterward side.

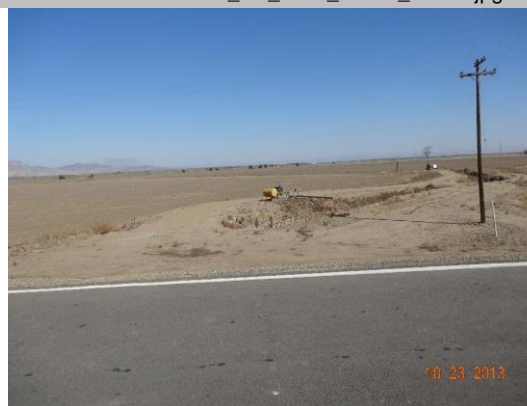
Photo 3 of 3 : UCIP_SP_2017_24229_42853.jpg

Comment Code					
Inspector Comment					
FS_ID:24229					
DS_ID:21421					
EP_NO: 9990					
Repair Type: Non-Urgent					
Crossing Status: Found					
UCIP Comments: Need to determine if crossings are still being used.					
This crossing is referenced in the USACE Periodic Inspection as item					
USACE_CESPK_MRD2_2012_p_0685.					
FIELD_STRUCT_DESC: 1 of 2: 24-inch steel pipe sleeved through a 30-					
inch steel pipe through the levee, 24.0 feet below the crown. Gate					
valves on waterward end. Concrete headwall with flap gate on landward					
side. Pumps on pile structure in stream. Wooden walkway to pumps.					
(USACE-1953). This entry matches the Drainage or Irrigation Structure					
referenced in O&M manual (Station 1086+55). This pipe was retained					
under ABO No. 9990 (1974).					
FS Date: 10/23/2013

Overview of landward side.

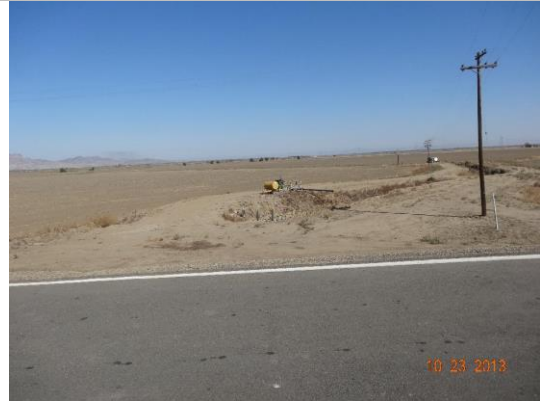
Photo 3 of 3 : UCIP_SP_2017_24230_42858.jpg

Comment Code					
Inspector Comment					
FS_ID:24230 DS_ID:21409 EP_NO: 9990 Repair Type: Non-Urgent Crossing Status: Found UCIP Comments: Need to determine if crossing is still being used. This crossing is referenced in the USACE Periodic Inspection as item USACE_CESPK_MRD2_2012_p_0685. FIELD_STRUCT_DESC: 2 of 2: 24-inch steel pipe sleeved through a 30-inch steel pipe through the levee, 24.0 feet below the crown. Gate valves on waterward end. Concrete headwall with flap gate on landward side. Pumps on pile structure in stream. Wooden walkway to pumps. (USACE-1953). This entry matches the Drainage or Irrigation Structure referenced in O&M manual (Station 1086+55). This pipe was retained under ABO No. 9990 (1974). FS Date: 10/23/2013

Overview of landward side.

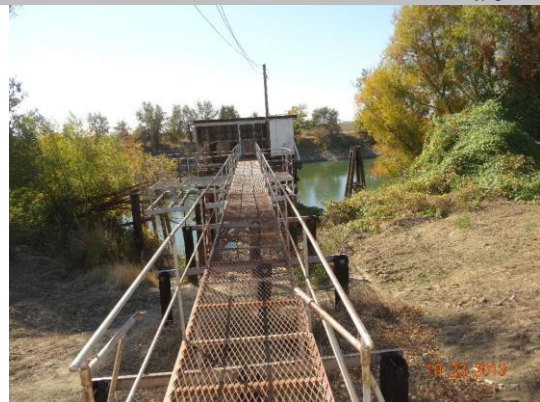
Photo 1 of 3 : UCIP_SP_2017_24231_42859.jpg

LM Start	15.34	Rating **	M	Issue No.	112
LM End	15.34	Issue Type +	En	Location *	WS
Category	Supplemental			GPS Latitude/Longitude	
				Start	End
Item	DWR UCIP Field Study			39.065285 °	39.065285 °
				-121.839202 °	-121.839202 °
DWR ID					
Comment Code					
Inspector Comment					
FS_ID:24231 DS_ID:21420 EP_NO: N/A Repair Type: Non-Urgent Crossing Status: Found UCIP Comments: No daylight visible on landward side. Pipe was visible on waterward side. Need to contact owner to determine status of crossing. This crossing is referenced in the USACE Periodic Inspection as item USACE_CESPK_MRD2_2012_p_0685. FIELD_STRUCT_DESC: 16-inch steel pipe through the levee, approximately 15.0 feet below the crown. Gate valves on waterward end. Pumps on waterward side. (USACE-1953). This entry matches the Drainage or Irrigation Structure referenced in O&M manual (Station 1086+55). FS Date: 10/23/2013

Walkway and structure located on waterward side.

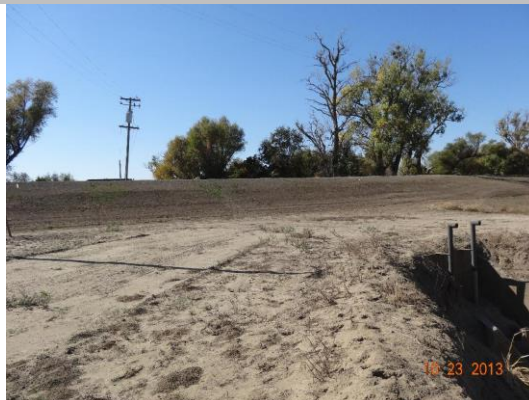
Photo 3 of 3 : UCIP_SP_2017_24231_42860.jpg

View of landward side photo taken from concrete headwall.
